# Federal Data Center Perimeter Security with RaySense and PulseVi

How a federal agency data center replaced a failing copper fence sensor across a 2.5 km perimeter: two sensor lines on a mid-railed fence, 11 zones with point-accurate location, four PulseVi LiDAR on the gates, and a cutover with no coverage gap.

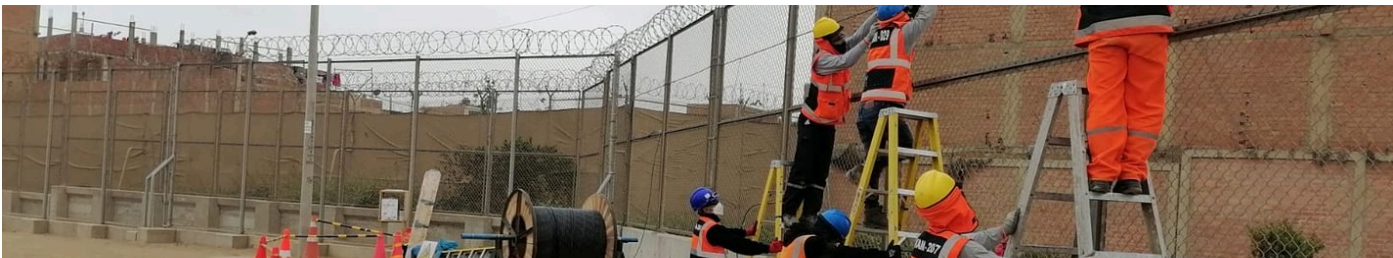
RAYSENSE INSTALLATION ON A PERIMETER FENCE. REPRESENTATIVE PHOTOGRAPHY; CUSTOMER IDENTITY WITHHELD.

RaySense AI DAS fiber optic sensing runs the full perimeter in two parallel lines, one above the mid-rail and one below, for roughly 5 km of sensor cable in total. Four PulseVi 3D Solid-State LiDAR units cover the gates, where fence detection stops and controlled access begins.

| Sensor lines | Two runs, above and below the fence mid-rail, approximately 5 km of sensor cable |
